New Hampshire Department of Safety Division of Homeland Security and Emergency Management

Mitigation Success Story

Marlow Hill Road, Marlow, New Hampshire

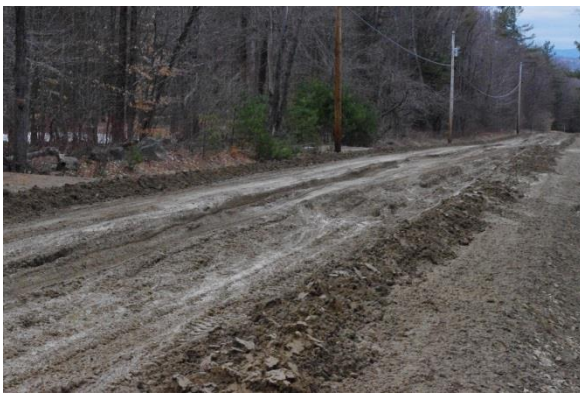
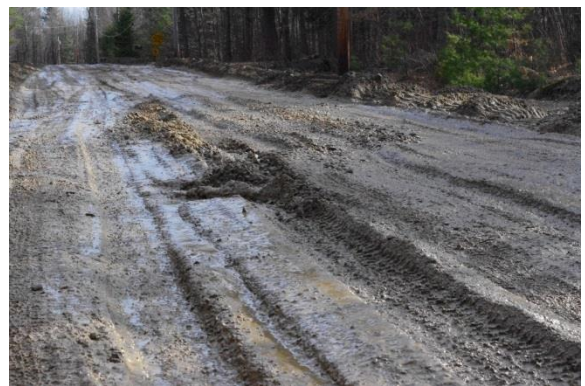
Before Mitigation

Prior to mitigation, Marlow Hill Road became impassable during the spring thaw cycle due to an inadequate road base. As a result of the growth in development over the last thirty years the road could no longer withstand the volume of traffic that now uses the route and resulted in increased response times for emergency services.

Following the award of funding from the Hazard Mitigation Grant Program (HMGP) an underdrain system was installed on Marlow Hill Road. In addition to the underdrain system, the project replaced two undersized 15"x40' CMP Culverts with 18" HDPE culverts and one undersized 18"x40' CMP culvert with a 24" HDPE culvert.

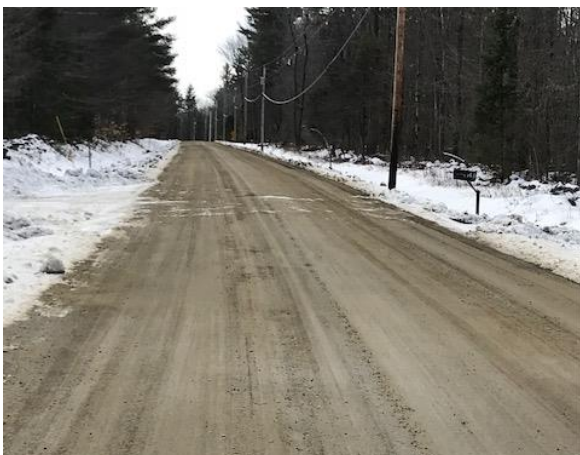
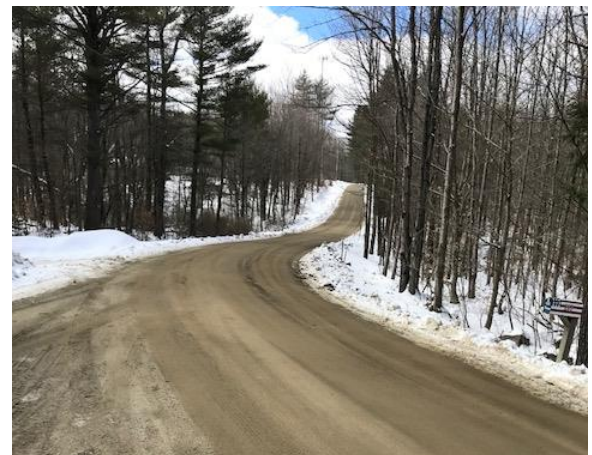
After Mitigation

The improved underdrain system has been tested by major rain/precipitation events and performed as expected, thereby eliminating the problems that existed previously.
